# case study

## Impressive results from castor wheel test

Product tested: **Bolon 3.4mm woven vinyl flooring (tiles) on InstaLay 30hg acoustic underlay**

Independent UKAS accredited testing facility: **BTTG Testing & Certification Ltd**

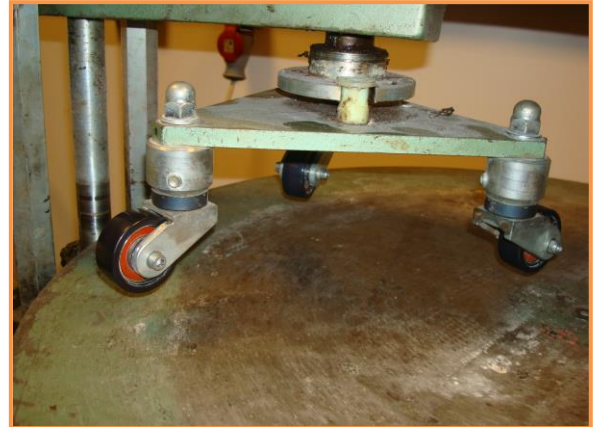
Castor wheel configuration

The flooring sample was prepared and then subjected to 25,000 continuous castor wheel revolutions, with a one hour rest after every 1,000 revolutions. The wheel direction was reversed every three minutes and the castors were loaded to 90kgs (approx. 14 stones), in order to simulate human weight and provide aggressive test conditions.

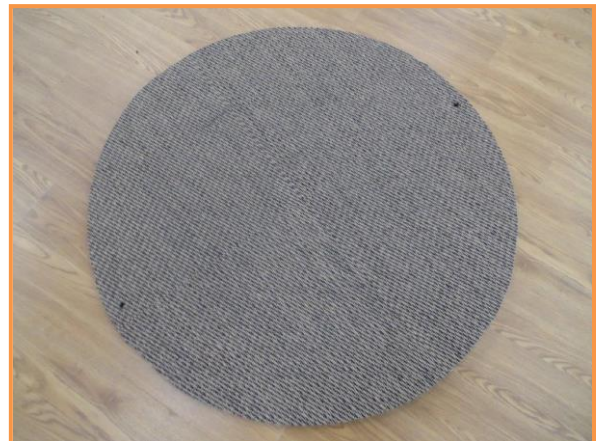
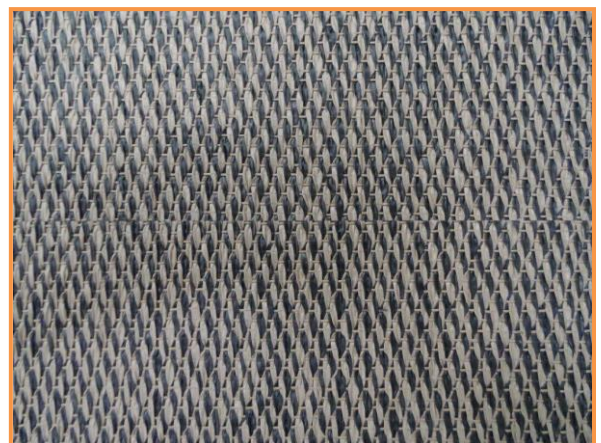
Bolon tile before the test (above) and after (below)

- The InstaLay 30hg (3mm high grab) was extremely robust and resilient and was able to easily and firmly bond the woven vinyl flooring without any signs of delamination.
- At the end of the test the joints of the woven vinyl flooring remained tight and intact, with no signs of them raising or gapping.
- The woven vinyl flooring remained fully intact and completely undamaged.
